1008 POLLOKSHAWS ROAD GLASGOW

ASBESTOS MANAGEMENT SURVEY

Report No.

AMJ-24-185

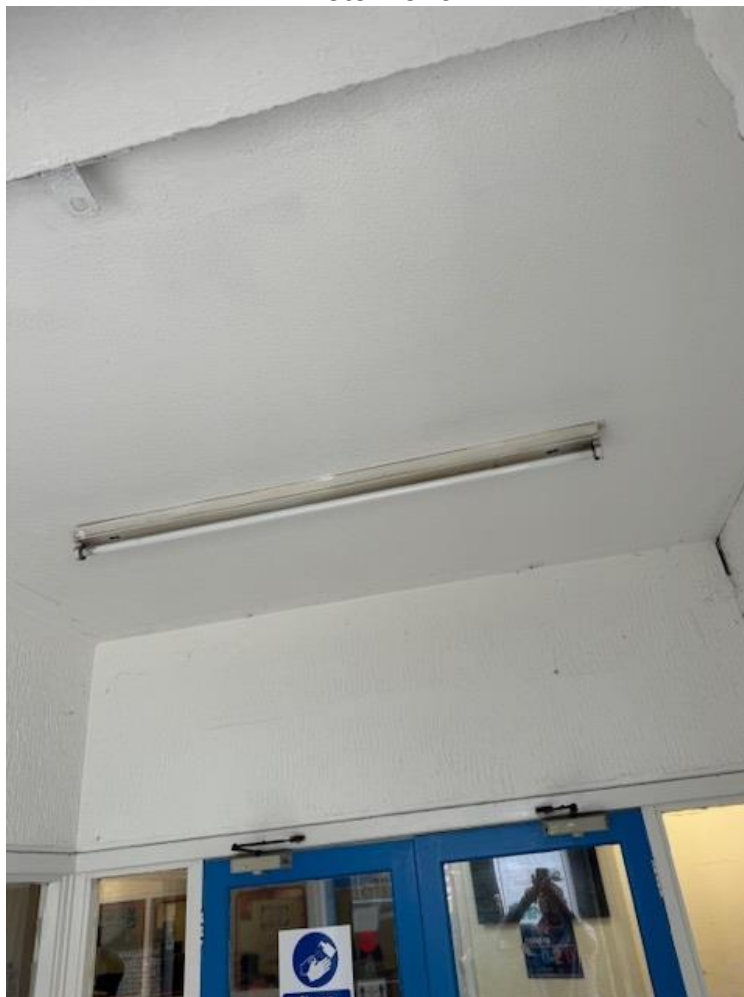
Photo No. 01

| Sample No. | Photo No. | Plan Ref. | Location | Surface | Product Type | Extent of Material | Sampled (S)<br>Presumed (P)<br>Strongly Presumed (SP) | Product Type (1 to 3) | Damage / Deterioration (0-3) | Surface Treatment (0-3) | Asbestos Type (1-3) | Material Score (2-12) | Surveyors Recommendations + (Comments) |
|---|---|---|---|---|---|---|---|---|---|---|---|---|---|
| 01 | 01 | 01 | Entrance Vestibule | Ceiling | Textured Coating | 6M2 | S | No Asbestos Detected | | | | | Concrete Ceiling & Walls Concrete Floor |

| Building Name / Number | Floor / Level | Room / Area | Location / Description |
|---|---|---|---|
| Comments | No Asbestos Detected, No Further Action Required | | |

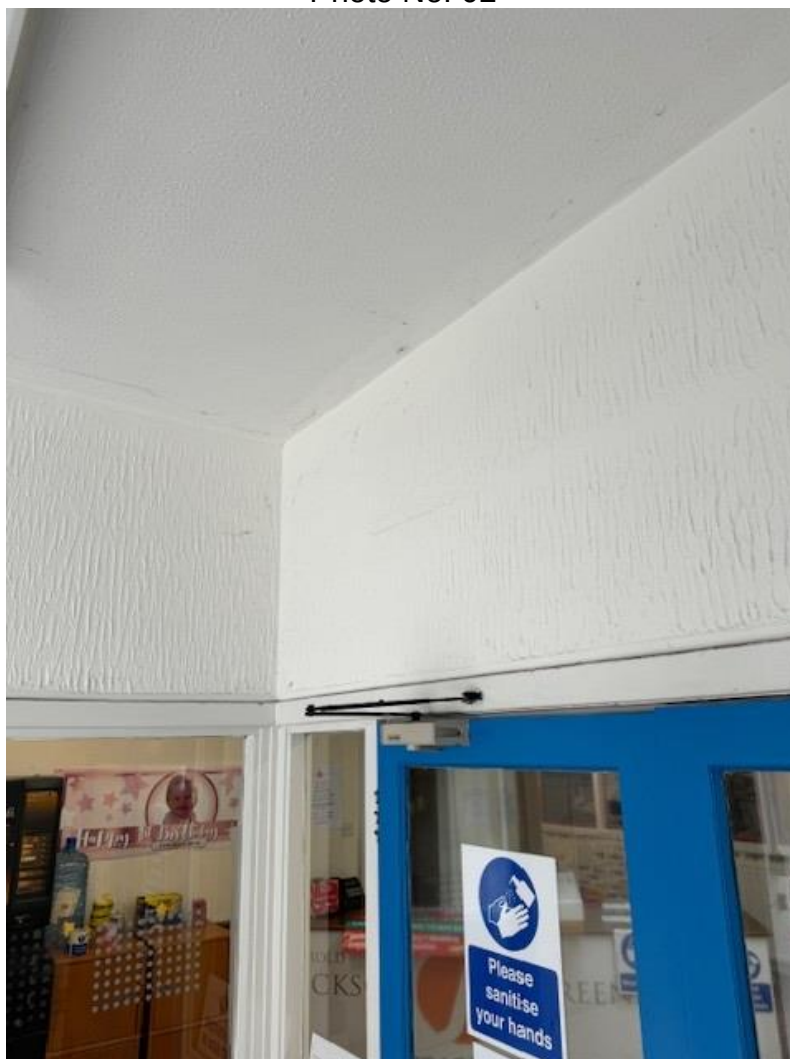
Photo No. 02

| Sample No. | Photo No. | Plan Ref. | Location | Surface | Product Type | Extent of Material | Sampled (S)<br>Presumed (P)<br>Strongly Presumed (SP) | Product Type (1 to 3) | Damage / Deterioration (0-3) | Surface Treatment (0-3) | Asbestos Type (1-3) | Material Score (2-12) | Surveyors Recommendations + (Comments) |
|---|---|---|---|---|---|---|---|---|---|---|---|---|---|
| 02 | 02 | 01 | Entrance Vestibule | Walls | Textured Coating | 5M2 | S | No Asbestos Detected | | | | | Concrete Ceiling & Walls Concrete Floor |

| Building Name / Number | Floor / Level | Room / Area | Location / Description |
|---|---|---|---|
| Comments | No Asbestos Detected, No Further Action Required | | |

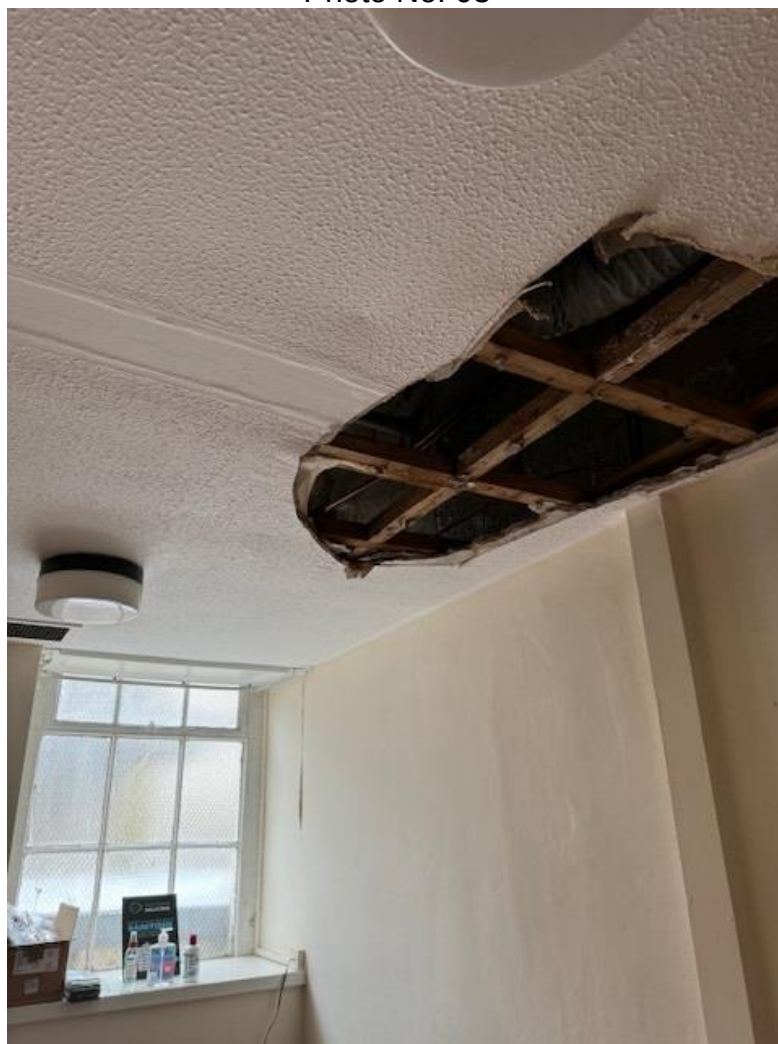
Photo No. 03

| Sample No. | Photo No. | Plan Ref. | Location | Surface | Product Type | Extent of Material | Sampled (S)<br>Presumed (P)<br>Strongly Presumed (SP) | Product Type (1 to 3) | Damage / Deterioration (0-3) | Surface Treatment (0-3) | Asbestos Type (1-3) | Material Score (2-12) | Surveyors Recommendations + (Comments) |
|---|---|---|---|---|---|---|---|---|---|---|---|---|---|
| 03 | 03 | 12 | Office | Ceiling | Textured Coating | 8M2 | S | No Asbestos Detected | | | | | Plasterboard Ceiling & Walls Concrete Floor |

| Building Name / Number | Floor / Level | Room / Area | Location / Description |
|---|---|---|---|
| Comments | No Asbestos Detected, No Further Action Required | | |

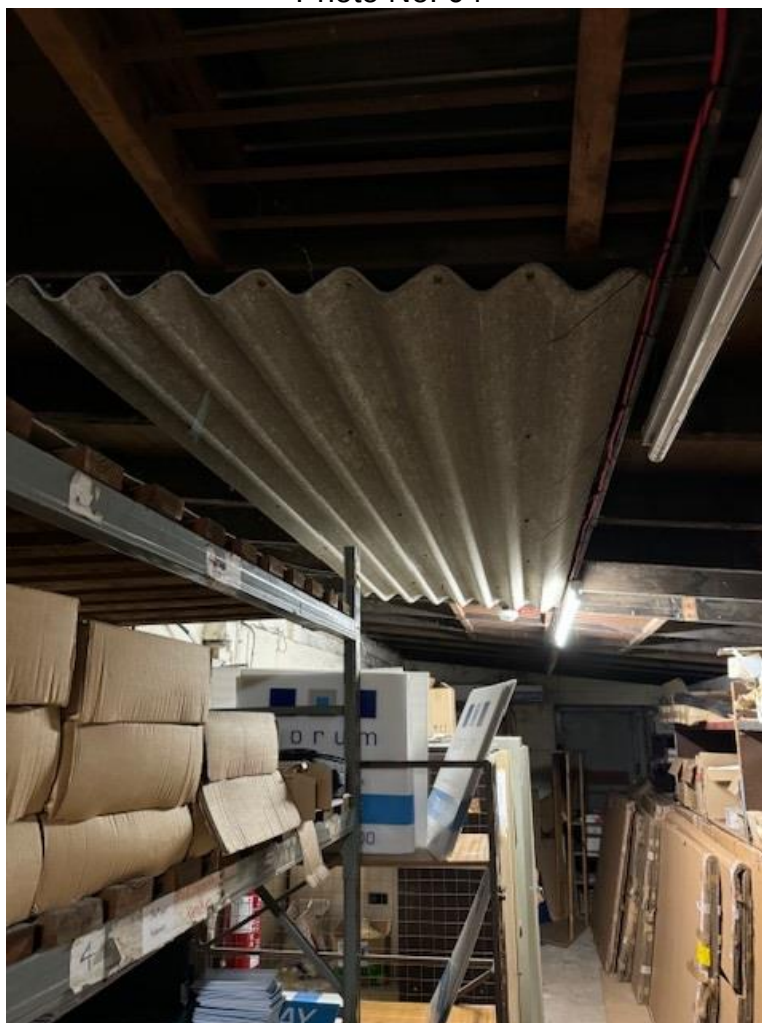
Photo No. 04

| Sample No. | Photo No. | Plan Ref. | Location | Surface | Product Type | Extent of Material | Sampled (S)<br>Presumed (P)<br>Strongly Presumed (SP) | Product Type (1 to 3) | Damage / Deterioration (0-3) | Surface Treatment (0-3) | Asbestos Type (1-3) | Material Score (2-12) | Surveyors Recommendations + (Comments) |
|---|---|---|---|---|---|---|---|---|---|---|---|---|---|
| 04 | 04 | 18 | Store | Ceiling Panel | Asbestos Cement | 3M2 | S | 1 | 1 | 1 | 1 | 4 | Label & Manage |

| Building Name / Number | Floor / Level | Room / Area | Location / Description |
|---|---|---|---|
| Comments | Label & Manage | | |

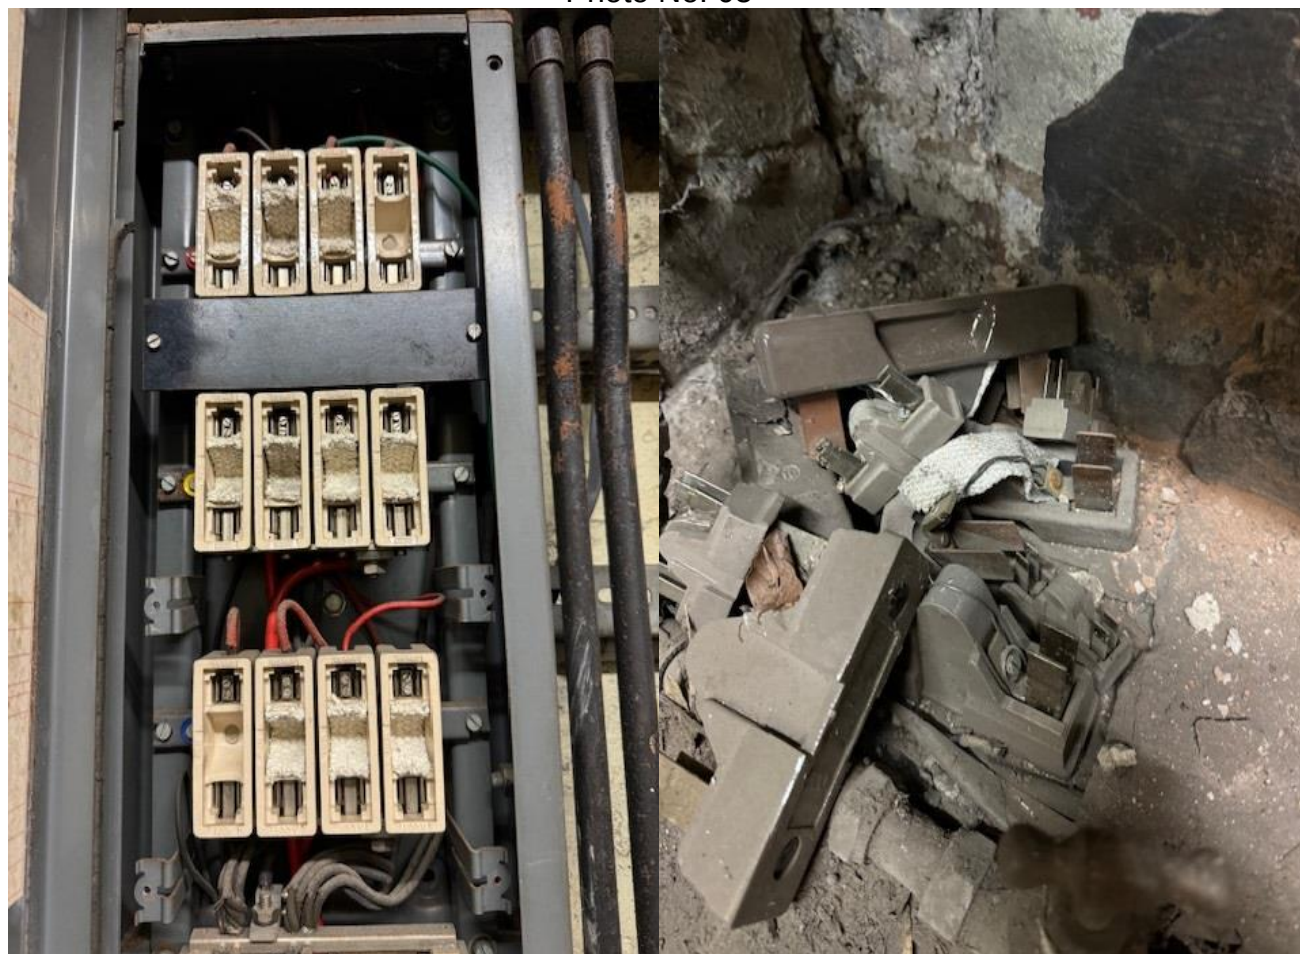
Photo No. 05

| Sample No. | Photo No. | Plan Ref. | Location | Surface | Product Type | Extent of Material | Sampled (S)<br>Presumed (P)<br>Strongly Presumed (SP) | Product Type (1 to 3) | Damage / Deterioration (0-3) | Surface Treatment (0-3) | Asbestos Type (1-3) | Material Score (2-12) | Surveyors Recommendations + (Comments) |
|---|---|---|---|---|---|---|---|---|---|---|---|---|---|
| 05 | 05 | 19 | Bottom Store | Fuse Boxes & Loose Fuses | Textile | 2M2 | S | 1 | 2 | 2 | 1 | 6 | Remove Loose Flash Guards Label & Manage |

| Building Name / Number | Floor / Level | Room / Area | Location / Description |
|---|---|---|---|
| 1008 Pollokshaws Road Glasgow | Ground Floor | Bottom Store | Fuse Boxes & Debris/Loose Fuses |

| Building Name / Number | Floor / Level | Room / Area | Location / Description |
|---|---|---|---|
| Comments | Remove Loose Flash Guards, Label & Manage | | |

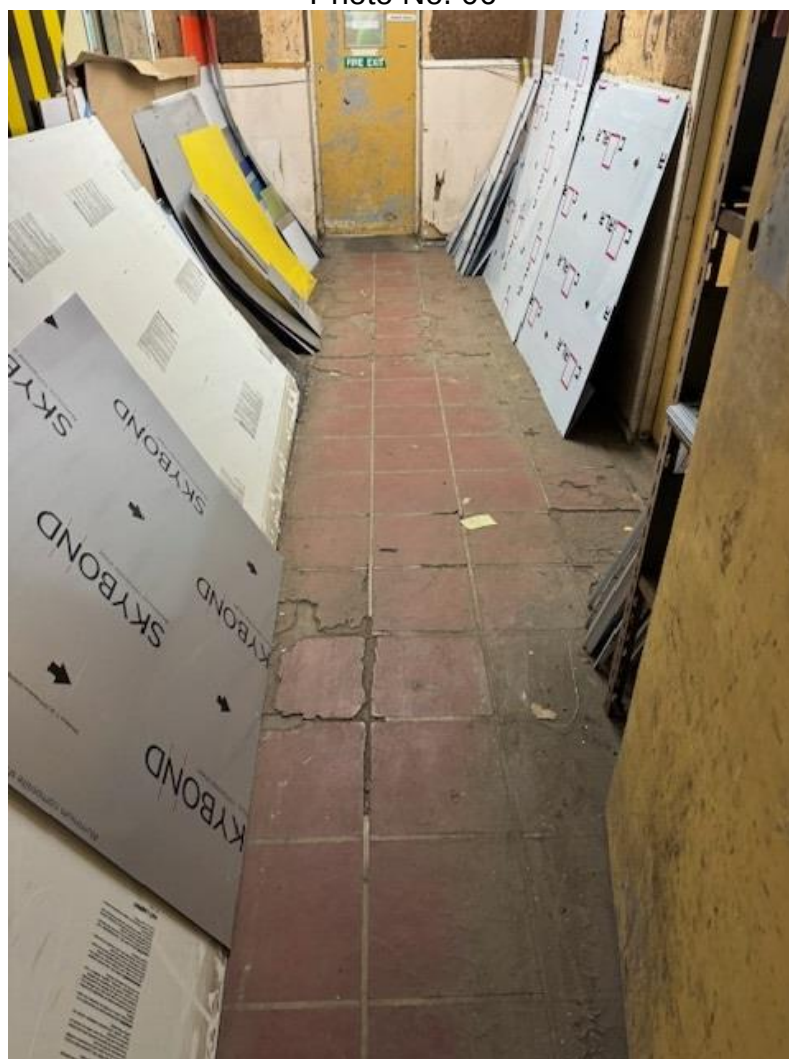
Photo No. 06

| Sample No. | Photo No. | Plan Ref. | Location | Surface | Product Type | Extent of Material | Sampled (S)<br>Presumed (P)<br>Strongly Presumed (SP) | Product Type (1 to 3) | Damage / Deterioration (0-3) | Surface Treatment (0-3) | Asbestos Type (1-3) | Material Score (2-12) | Surveyors Recommendations + (Comments) |
|---|---|---|---|---|---|---|---|---|---|---|---|---|---|
| 06 | 06 | 20 | Corridor | Floor | Floor Tiles | 15M2 | No Asbestos Detected | | | | | | Plasterboard Ceiling & Walls Concrete Floor |

| Building Name / Number | Floor / Level | Room / Area | Location / Description |
|---|---|---|---|
| Comments | No Asbestos Detected, No Further Action Required. | | |

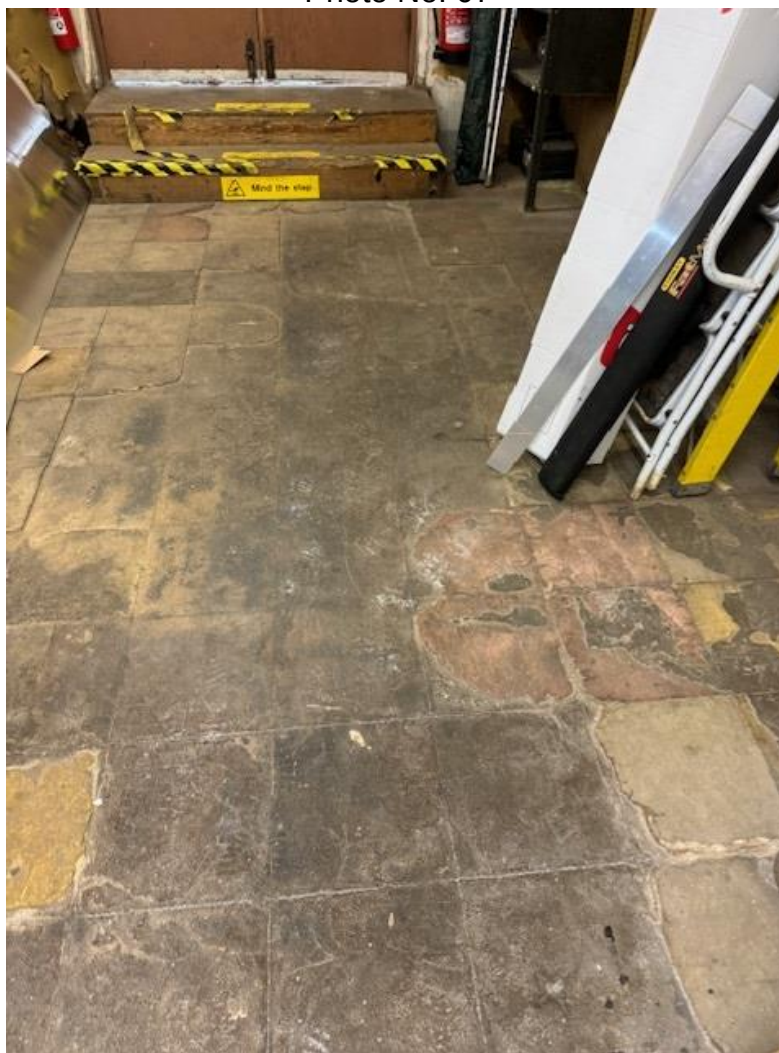
Photo No. 07

| Sample No. | Photo No. | Plan Ref. | Location | Surface | Product Type | Extent of Material | Sampled (S)<br>Presumed (P)<br>Strongly Presumed (SP) | Product Type (1 to 3) | Damage / Deterioration (0-3) | Surface Treatment (0-3) | Asbestos Type (1-3) | Material Score (2-12) | Surveyors Recommendations + (Comments) |
|---|---|---|---|---|---|---|---|---|---|---|---|---|---|
| 07 | 07 | 29 | Workshop | Floor | Floor Tiles | 70M2 | S | No Asbestos Detected | | | | | Plasterboard Ceiling & Walls Concrete Floor |

| Building Name / Number | Floor / Level | Room / Area | Location / Description |
|---|---|---|---|
| Comments | No Asbestos Detected, No Further Action Required | | |

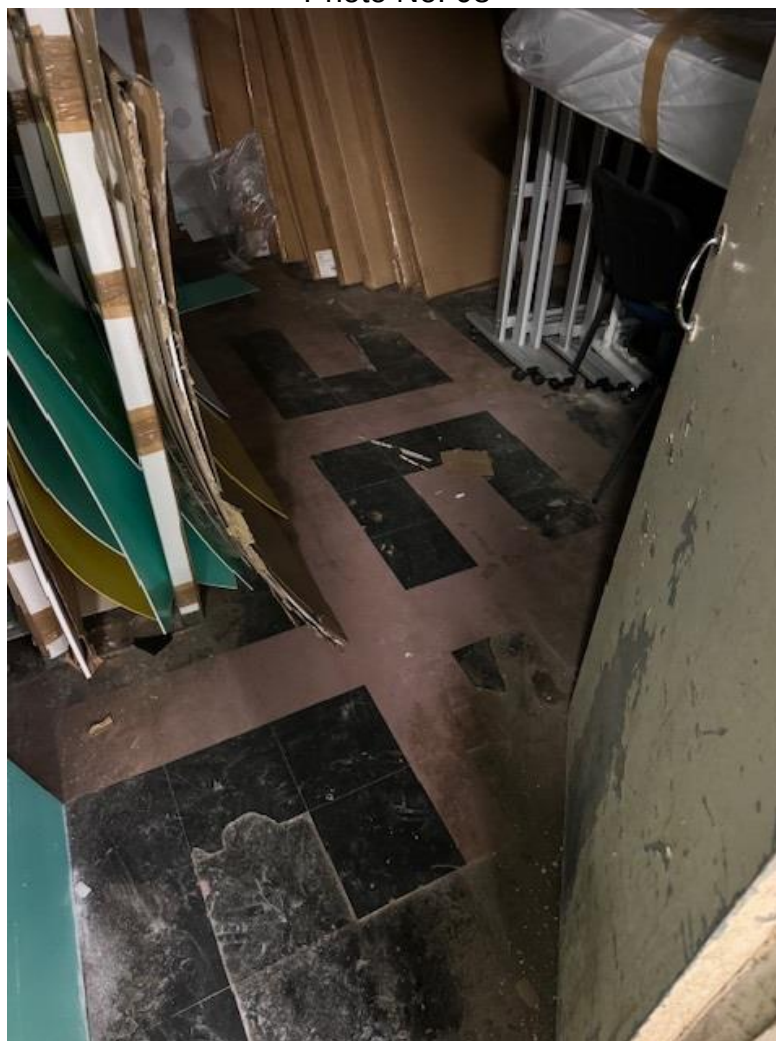
Photo No. 08

| Sample No. | Photo No. | Plan Ref. | Location | Surface | Product Type | Extent of Material | Sampled (S)<br>Presumed (P)<br>Strongly Presumed (SP) | Product Type (1 to 3) | Damage / Deterioration (0-3) | Surface Treatment (0-3) | Asbestos Type (1-3) | Material Score (2-12) | Surveyors Recommendations + (Comments) |
|---|---|---|---|---|---|---|---|---|---|---|---|---|---|
| 08 | 08 | 30 | Store | Floor | Floor Tiles & Adhesive | 25M2 | S | 1 | 1 | 1 | 1 | 4 | Remove Damaged Areas Label & Manage |

| Building Name / Number | Floor / Level | Room / Area | Location / Description |
|---|---|---|---|
| Comments | Remove Damaged Areas, Label & Manage | | |

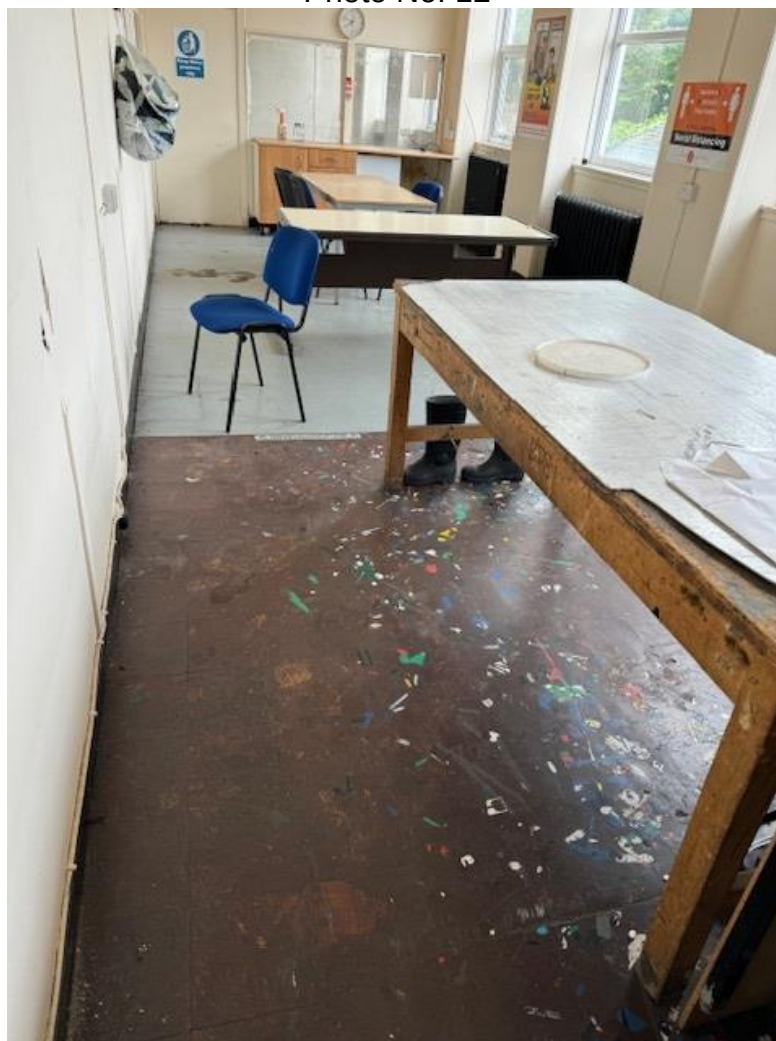
Photo No. 12

| Sample No. | Photo No. | Plan Ref. | Location | Surface | Product Type | Extent of Material | Sampled (S)<br>Presumed (P)<br>Strongly Presumed (SP) | Product Type (1 to 3) | Damage / Deterioration (0-3) | Surface Treatment (0-3) | Asbestos Type (1-3) | Material Score (2-12) | Surveyors Recommendations + (Comments) |
|---|---|---|---|---|---|---|---|---|---|---|---|---|---|
| 11 | 12 | 41 | Canteen | Floor | Floor Tiles & Adhesive | 30M2 | S | 1 | 1 | 1 | 1 | 4 | Remove Damaged Areas, Label & Manage |

| Building Name / Number | Floor / Level | Room / Area | Location / Description |
|---|---|---|---|
| Comments | Label & Manage, Remove Damaged Areas | | |

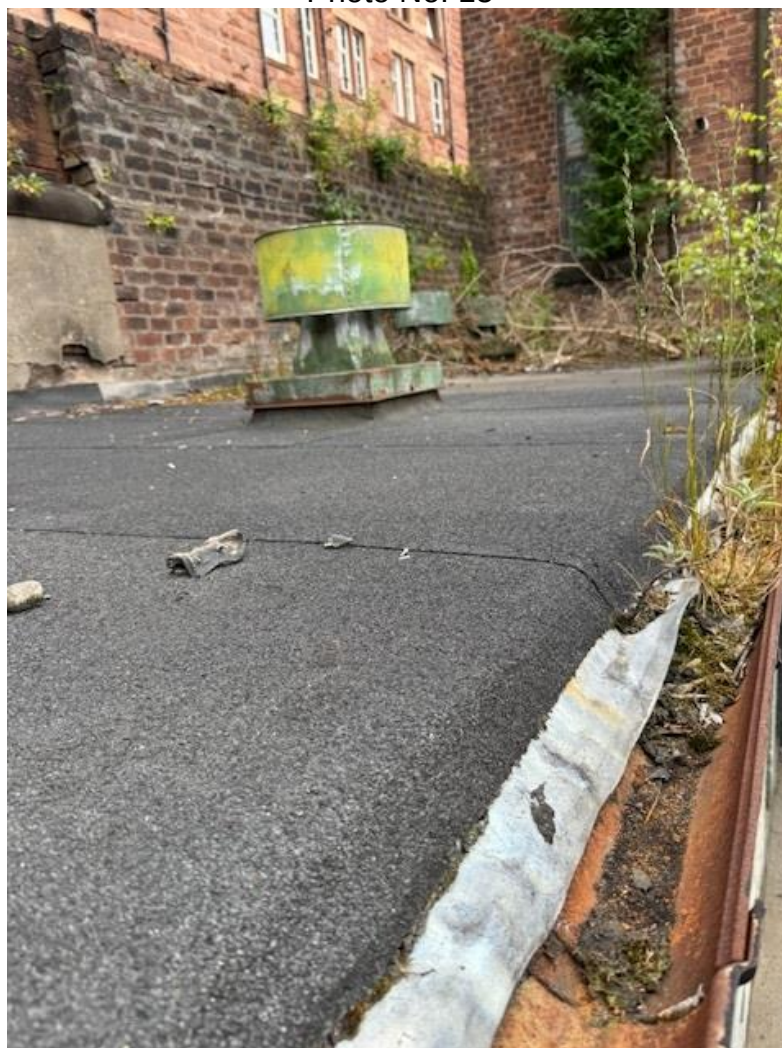
Photo No. 15

| Building Name / Number | Floor / Level | Room / Area | Location / Description |
|---|---|---|---|
| Comments | No Asbestos Detected, No Further Action Required | | |
